REPORT No. 20/2021

**EVALUATION OF AN INORGANIC SAMPLE THROUGH AN ENVIRONMENTAL
SCANNING ELECTRON MICROSCOPY INVESTIGATION AND AN X-RAY MICRO-
ANALYSIS**

Sample checked: Swabs for PCR test

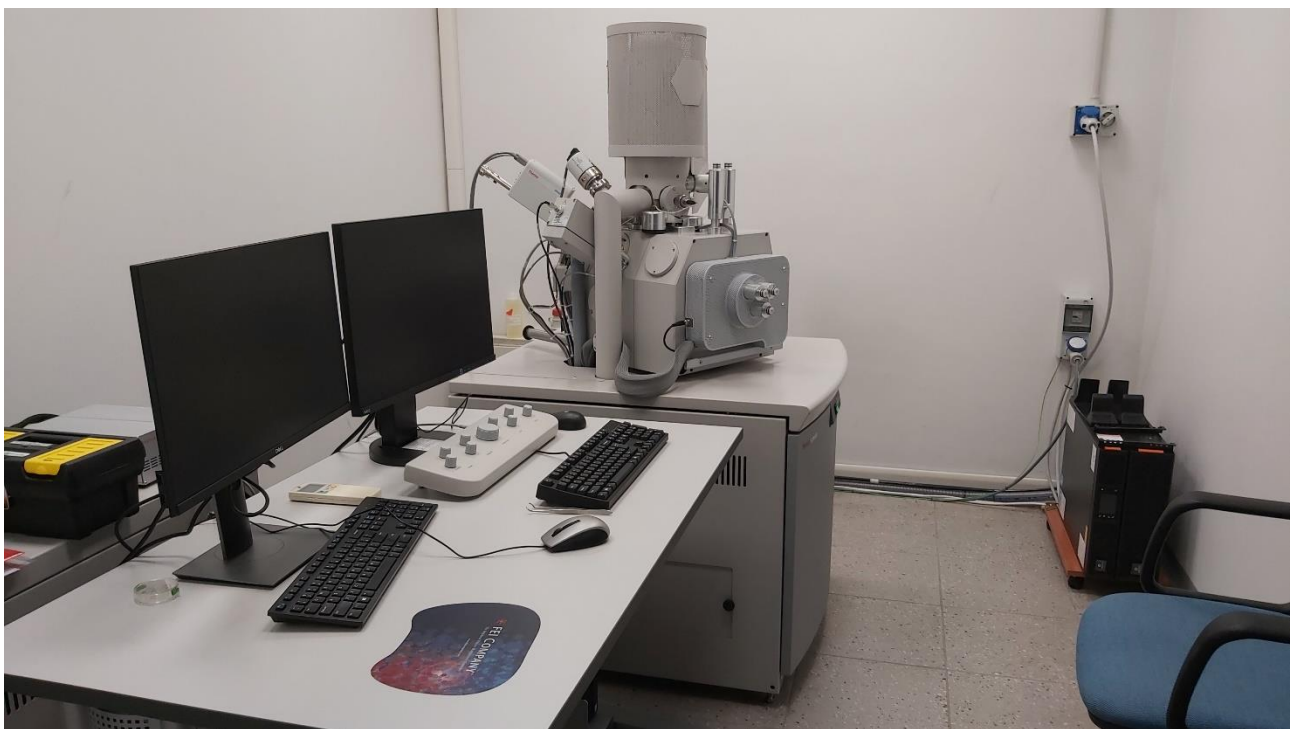
This kind of analysis offers the possibility to observe biological samples in wet mode, i.e., in the condition of their normal hydration, at environmental pressure, without the need to dehydrate them or make them electro-conductive through a coating of Carbon, or metals like Gold and Palladium, a procedure that is necessary with the traditional scanning electron microscopes.

By applying appropriate protocols to be adapted to each kind of observation, this feature allows to check biological samples, including living cells, without impairing their integrity, and to repeat the test any time. The main objective of the study is the detection of inorganic micro- and

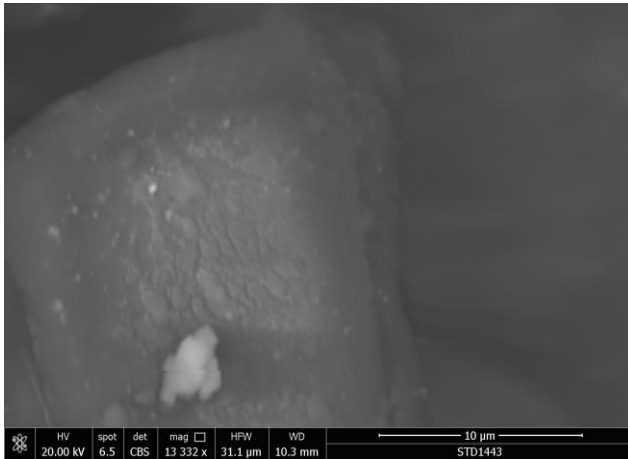
Analysis 7 of Table 1. The figure shows an area of the sample (magnification 3087x) where two debris are visible. The EDS analysis shows that the former is composed of Carbon, Oxygen, Calcium, Silicon, Aluminium, and Nitrogen; the second of Carbon, Oxygen, Silicon, Nitrogen and Aluminium. Fibres are dirty.
